# ALBANY UNIFIED SCHOOL DISTRICT SEISMIC EVALUATION

Prepared for WLC Architects and Albany USD

KPW Project No. 13C133

April 24, 2013

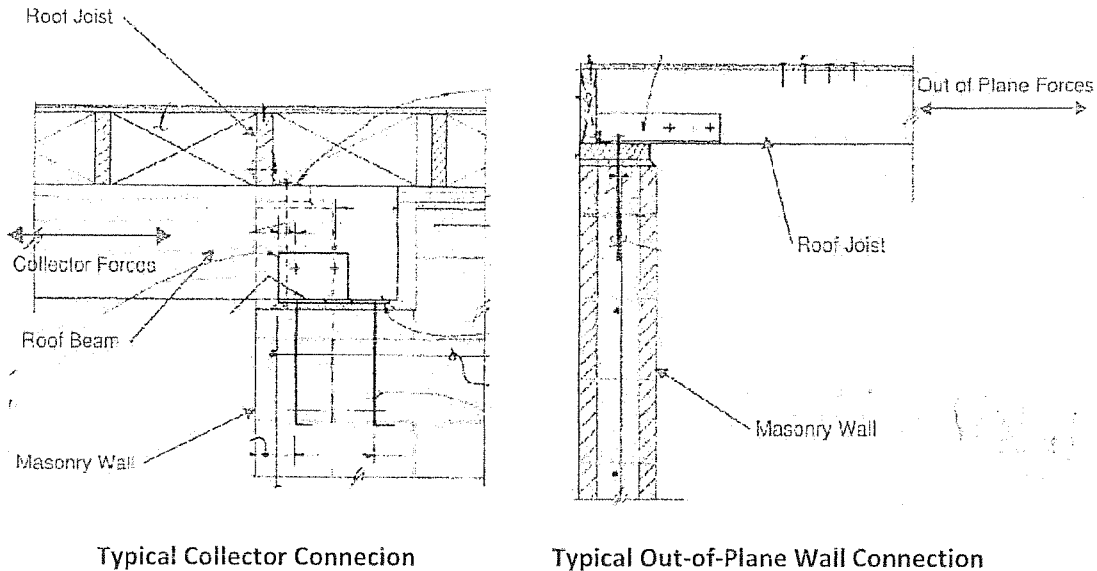
Figure 1: Typical Wall-Roof Connections

Our analysis found that in general the collector connections are significantly overstressed when compared to current code level forces. Refer to Figure 1 for a typical collector connection.

The out-of-plane wall connections at Ocean View generally consist of a steel angle bolted to the side of a roof joist and the top of the masonry wall as shown in figure 1. Our analysis of these connections found that they are significantly overstressed when subjected to the design forces of the current building code.

We would recommend that these deficient elements be strengthened as part of an overall seismic retrofit program. Retrofits of this nature are commonly performed and often can be implemented economically and with a minimal impact to the function or appearance of the buildings.
