Seismic Evaluation of Ocean View Elementary School

**Prepared for
Albany Unified School District
Albany, CA**

November 2012

**Prepared by
R. P. Gallagher Associates, Inc.
Structural Engineers
Oakland, CA**

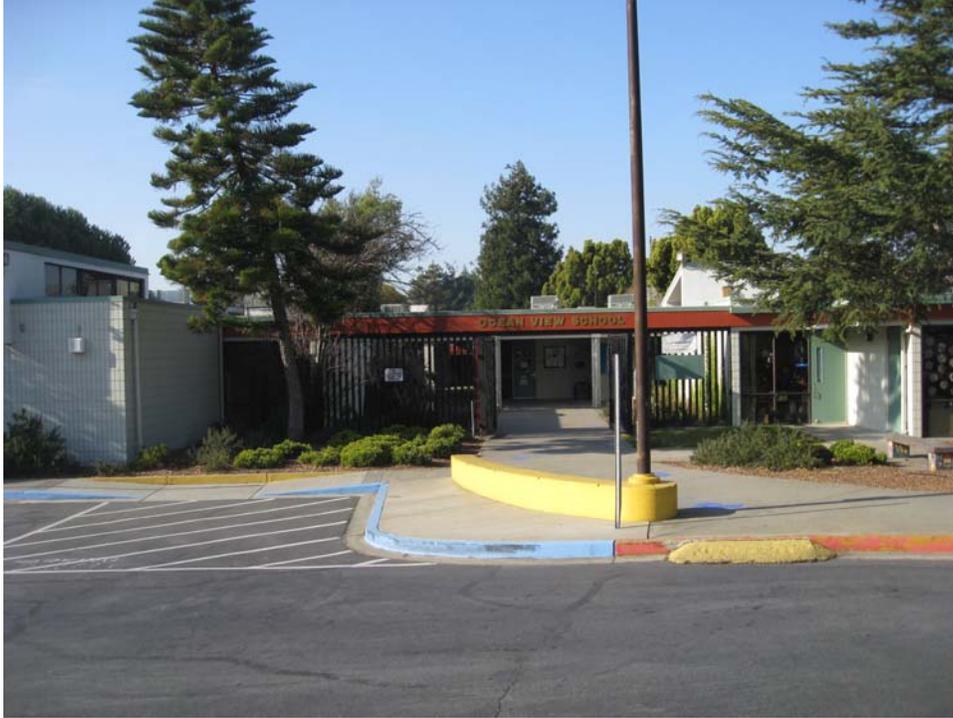
The main entrance to the school is shown in Figure 3. It appears that the original 3 x 4 wood posts for the fence and gates have been replaced by metal tubes. We had no information concerning this change. The entrance structure is laterally supporting the new gates and tube fence. It consists of a built-up horizontal wood box beam supported by two 12" CMU columns and 8" CMU walls at the ends. The 12" CMU columns are supported by spread footings. This structure was reviewed for ASCE 31 seismic forces and found to meet criteria.

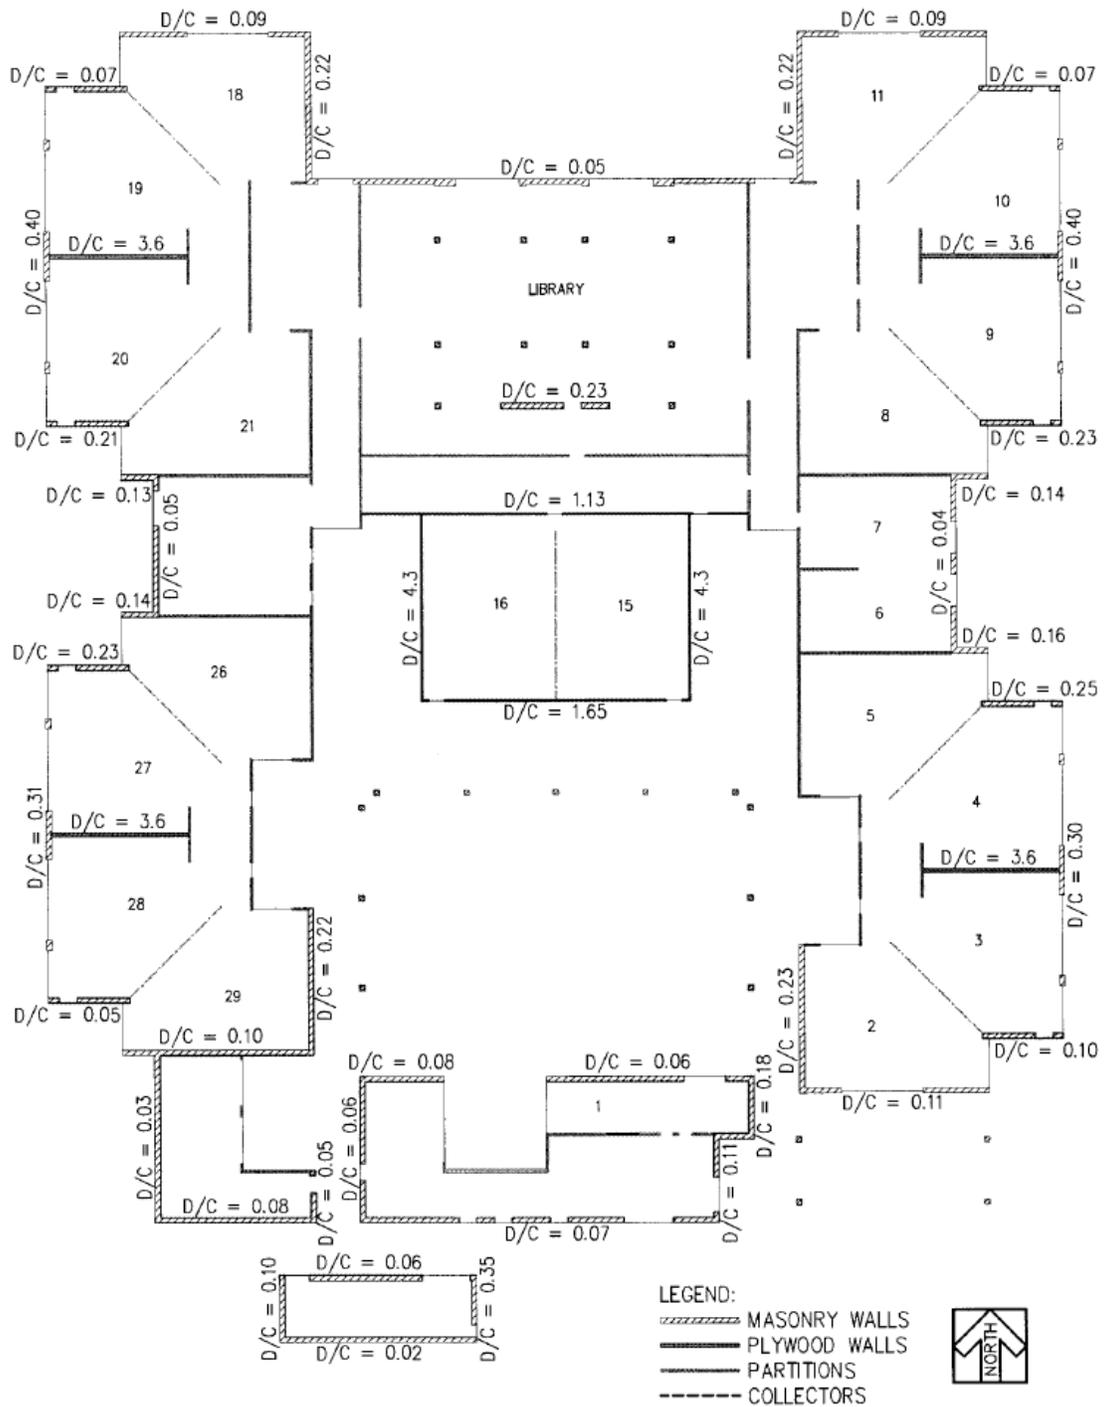
The plywood roof diaphragms and clerestories meet the ASCE 31 criteria. Many shear walls also meet criteria. Figure 11 summarized D/C ratios for the various masonry and plywood shear walls. Overall, the demand on the various masonry walls for in-plane shear force resistance is, on average, about 20% of their capacity. The D/C ratios vary from 0.02 to 0.40 for the masonry shear walls. The base of the masonry walls are adequately tied to the foundations and laterally restrained by the slab-on-grade construction that was doweled to the continuous spread footings.

The plywood sheathed shear walls resist a considerable amount of the building's seismic forces. The D/C ratios for in-plane shear are typically 0.70, indicating the walls are adequate for shear. The anchorage of the wood walls to the foundation, however, is not adequate. The element of concern is the sill plate anchorage to the foundations. The D/C ratios for sill plate

Figure 11 – Building A demand-to-capacity (D/C) ratios for shear wall strength.

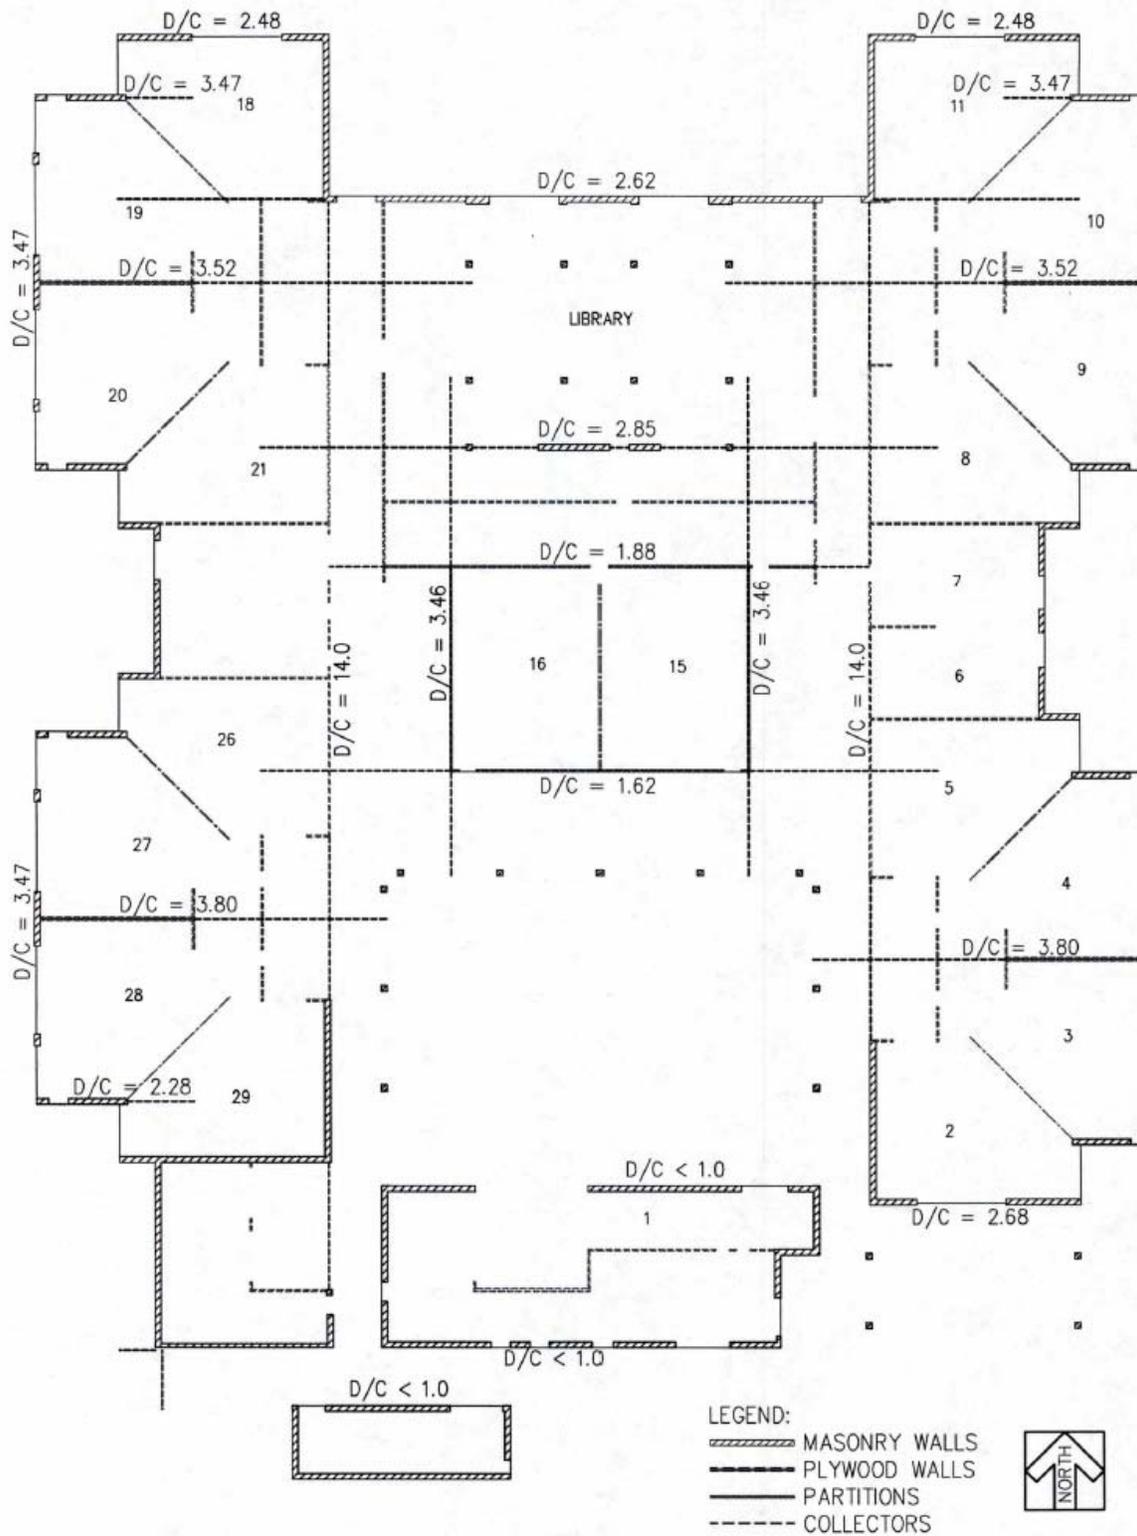
The transfer of roof seismic forces to the various shearwalls is critical. This is summarized on Figure 12. A check of the collectors indicate susceptibility to damage because of the weak nominal connections along the length of these elements. Many of the beams (glulam or sawn lumber) rely on nominal bolting or anchors to drag forces into the resisting shear walls. Most of these connections have a D/C ratio greater than 2.00. The connections along the north-south corridors of Building A have a very high D/C ratio of 14.0 (see Figure 15).

Figure 12 – Building A demand-to-capacity ratios (D/C) for the connection of the roof to the shear walls.

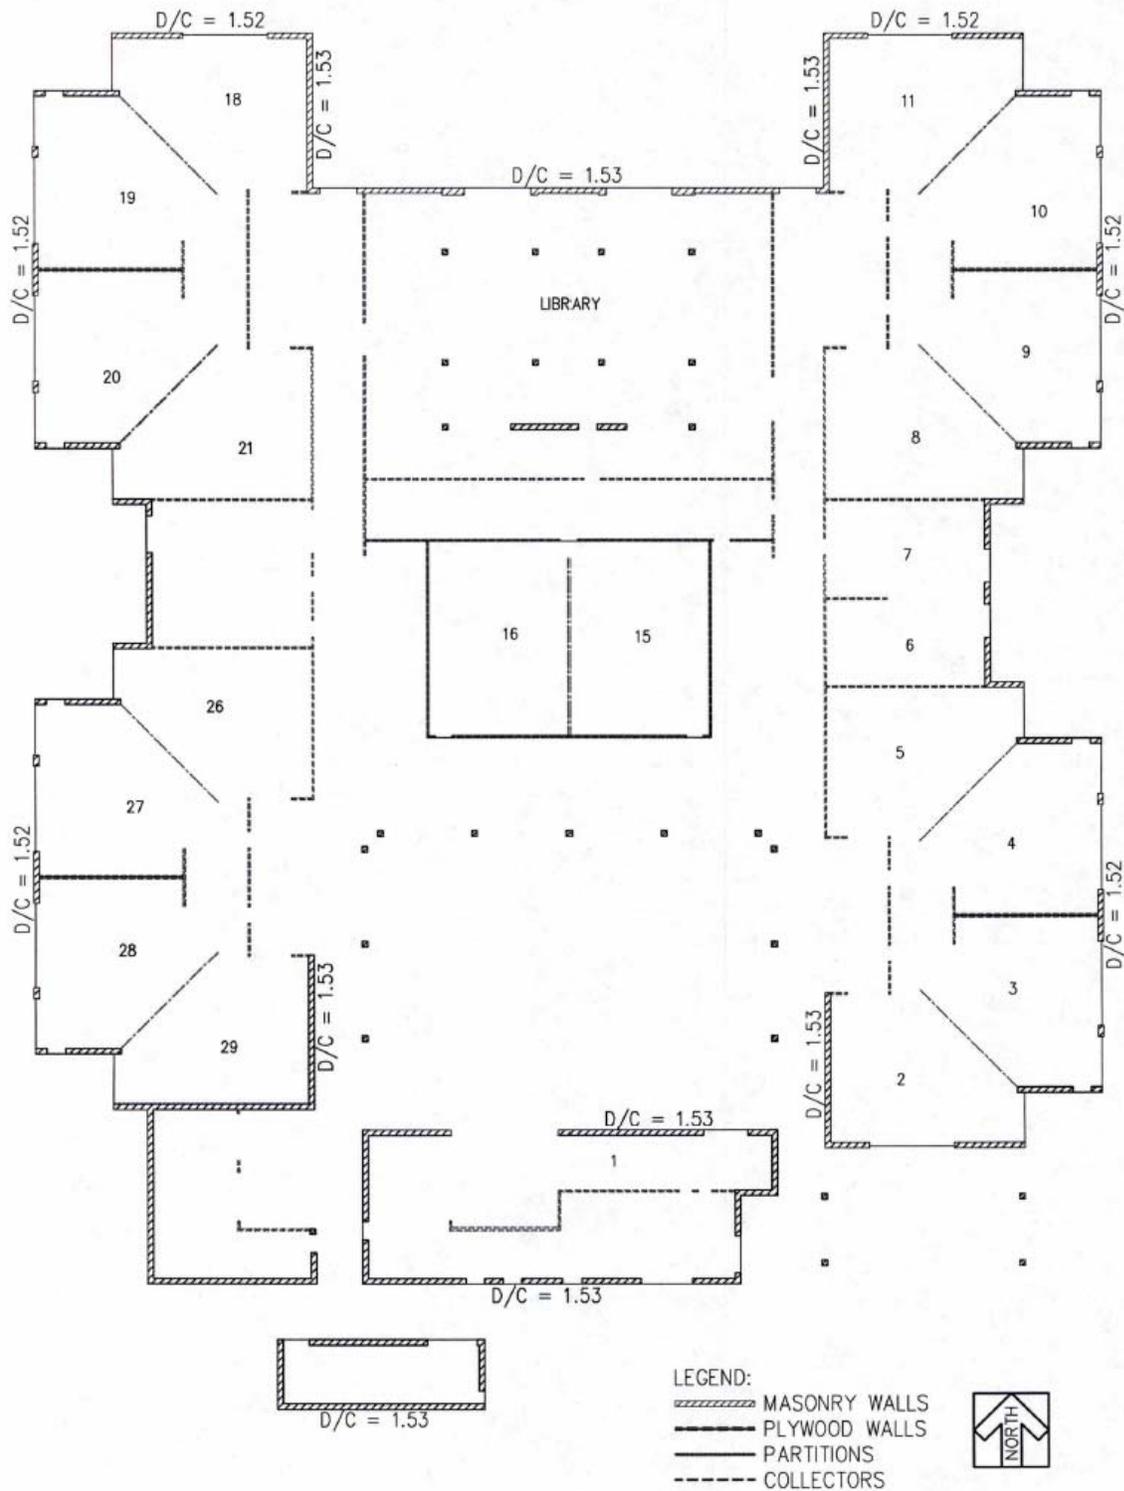
The masonry walls have adequate capacity for resisting out-of-plane seismic loading. However, the connection of the walls to the roof diaphragm is overstressed. Where the framing is bearing atop the masonry walls (see Figure 14), the minimal side cover of the anchor bolts results in a D/C ratio of 1.53. In other conditions where the roof framing is parallel to the masonry wall (see Figure 19 for an example), the H2 clips attaching the blocking limit the connection strength. Figure 13 summarize the D/C ratios for the wall-roof anchorage resisting out-of-plane forces.

Figure 13 – Building A demand-to-capacity ratios (D/C) for the anchorage of the walls to the roof for out-of-plane seismic forces.

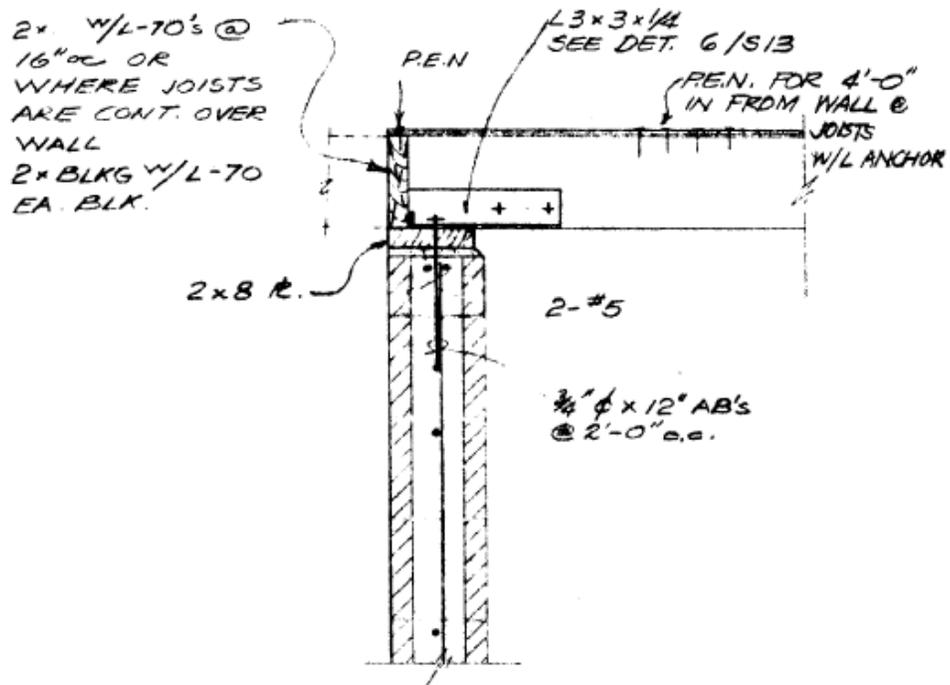
Figure 14 – An example of one of the wall-roof connections used in Buildings A and C. Because the anchor bolts in the masonry lack sufficient side cover, this connection is overstressed with a D/C of 1.53.

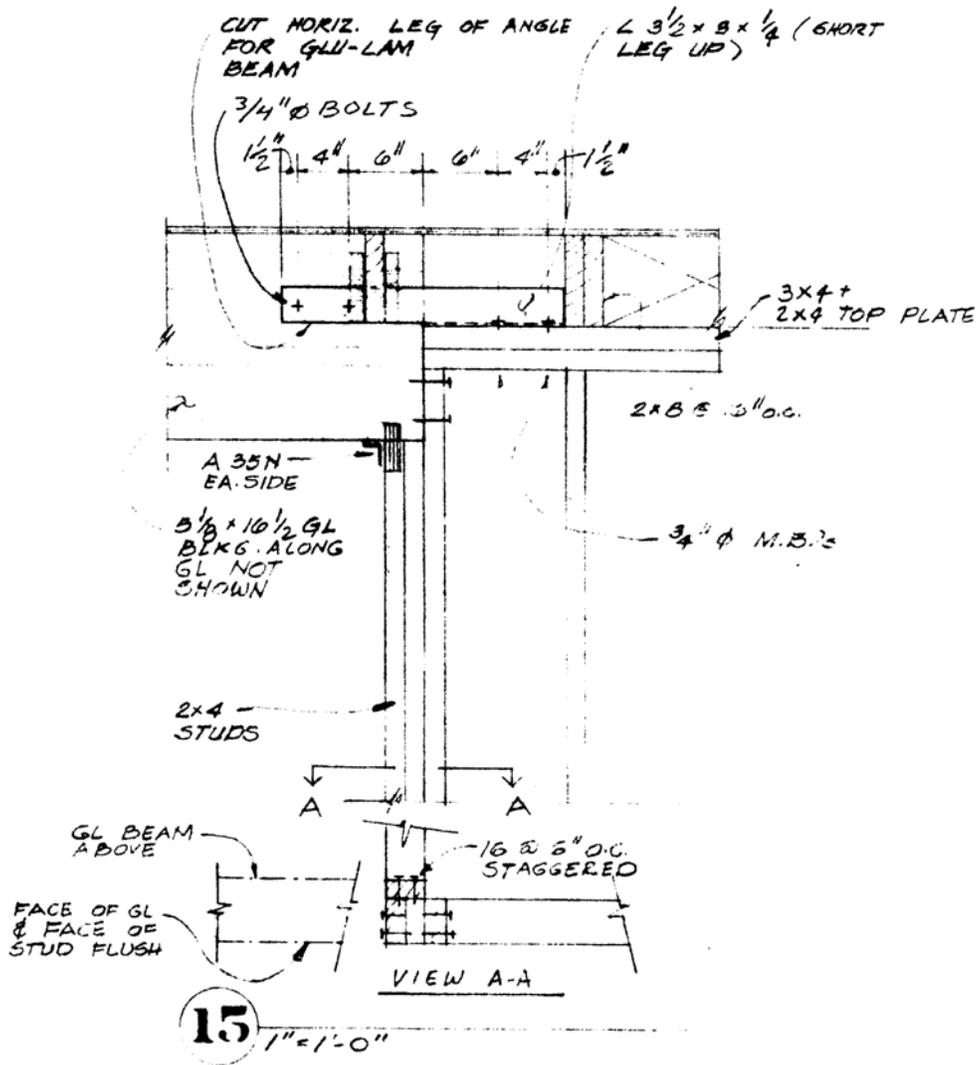
Figure 15 – Typical collector connection in Building A showing the attachment of a glulam beam to a wood wall. The strength of the connection is limited by the 3/4" bolts connecting the 3 1/2 x 3 angle to the glulam beam and the wood wall. The D/C ratio is very high 14.0.

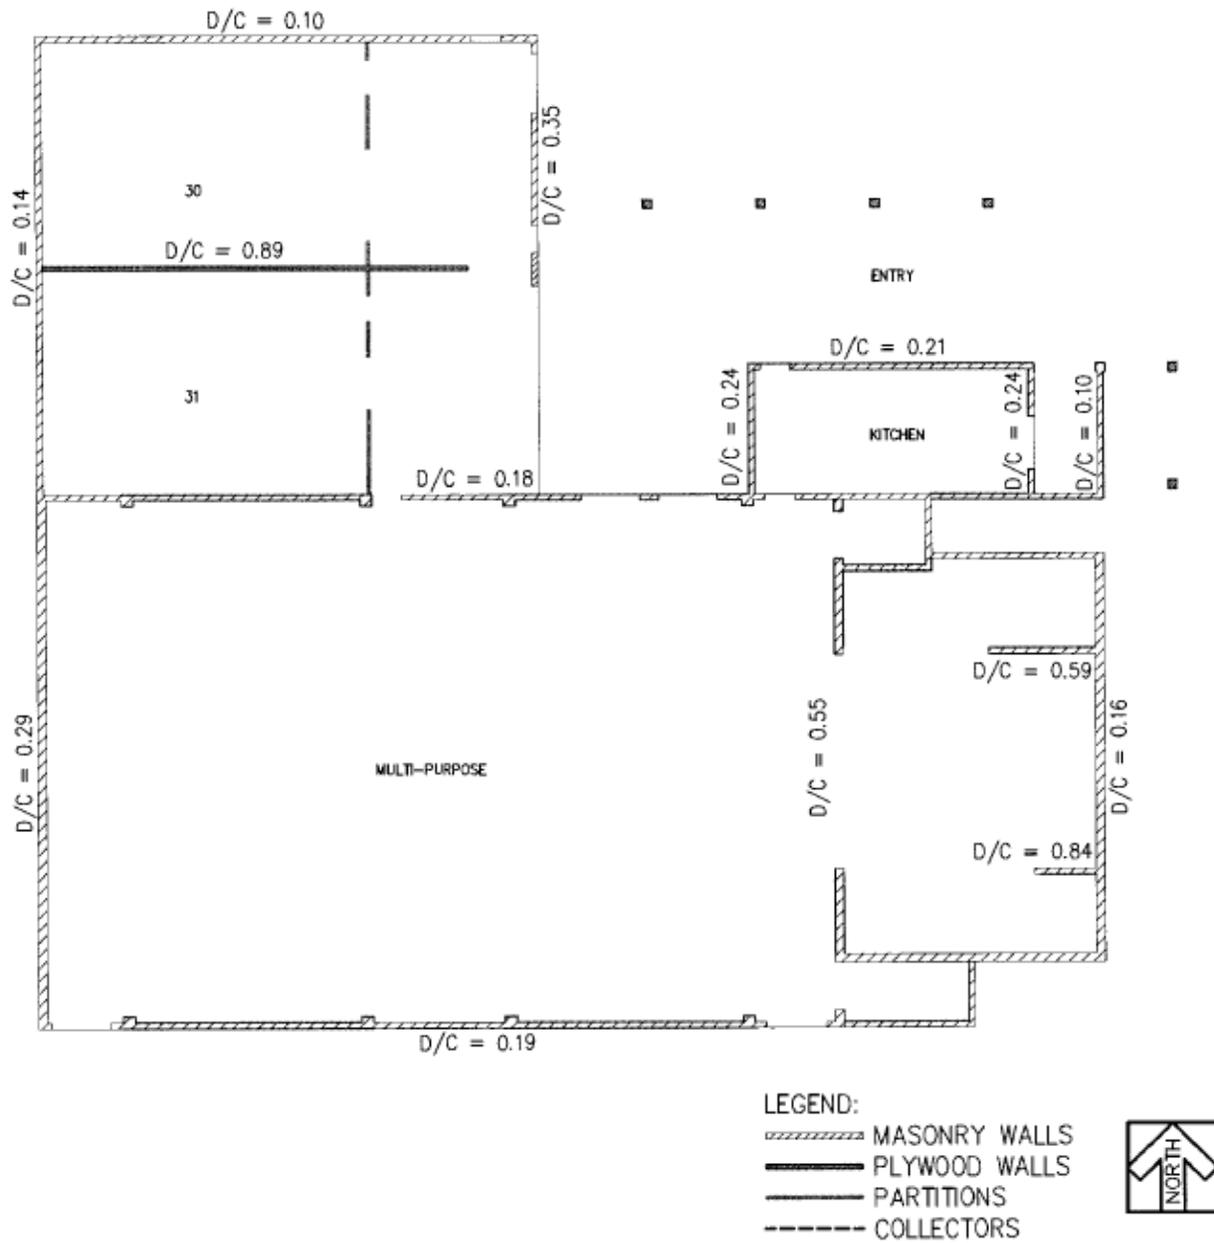
Figure 16 shows the D/C ratios for the in-plane strength of the CMU and plywood shear walls. All walls are in conformance with ASCE 31 requirements.

Figure 16 – Building B demand-to-capacity ratios (D/C) for shear wall strength.

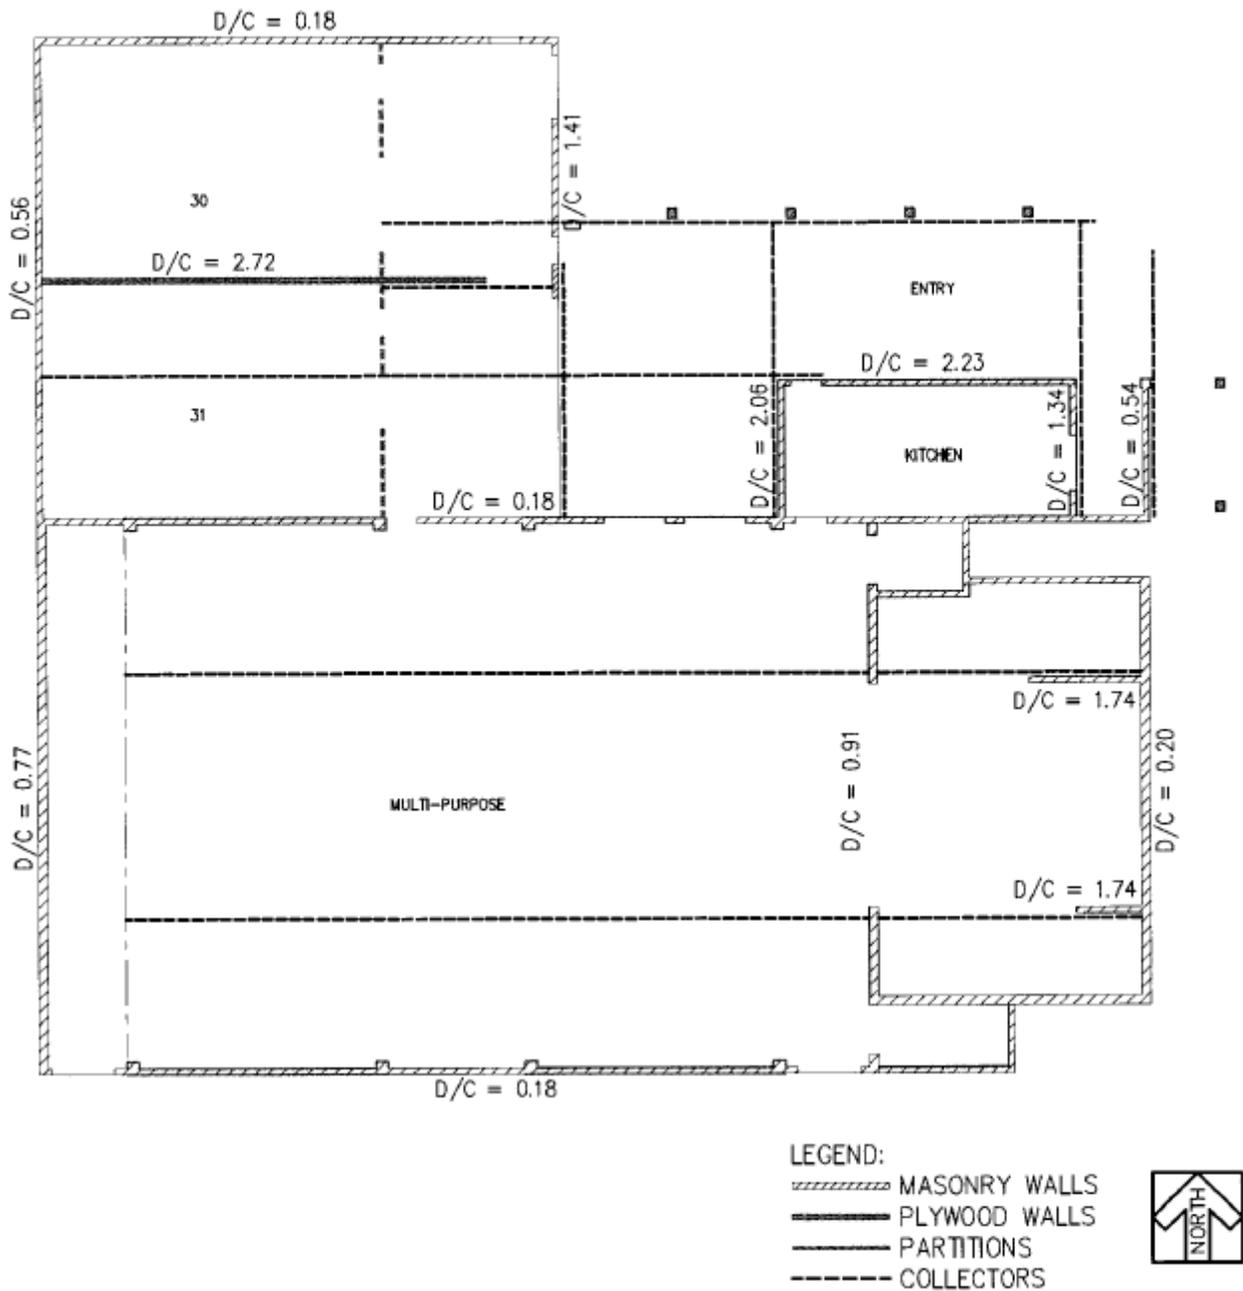
Another structural deficiency is the weak in-plane connection between wood roof and the walls of the building. The D/C ratios for various walls are given in Figure 17. This deficiency has two components: (1) the direct connection between the roof and the top of the wall; and (2) the strength of the collector (see Figure 15 for an example) which is the structural element that gathers the tributary roof seismic force and transfers it to the wall. Non-conformance of either component means that strengthening is required by the criteria. Only some of the walls are not in compliance, and most of these are those with overstressed collector connections.

Figure 17 – Building B demand-to-capacity ratios (D/C) for the connection of the roof to the shear walls.

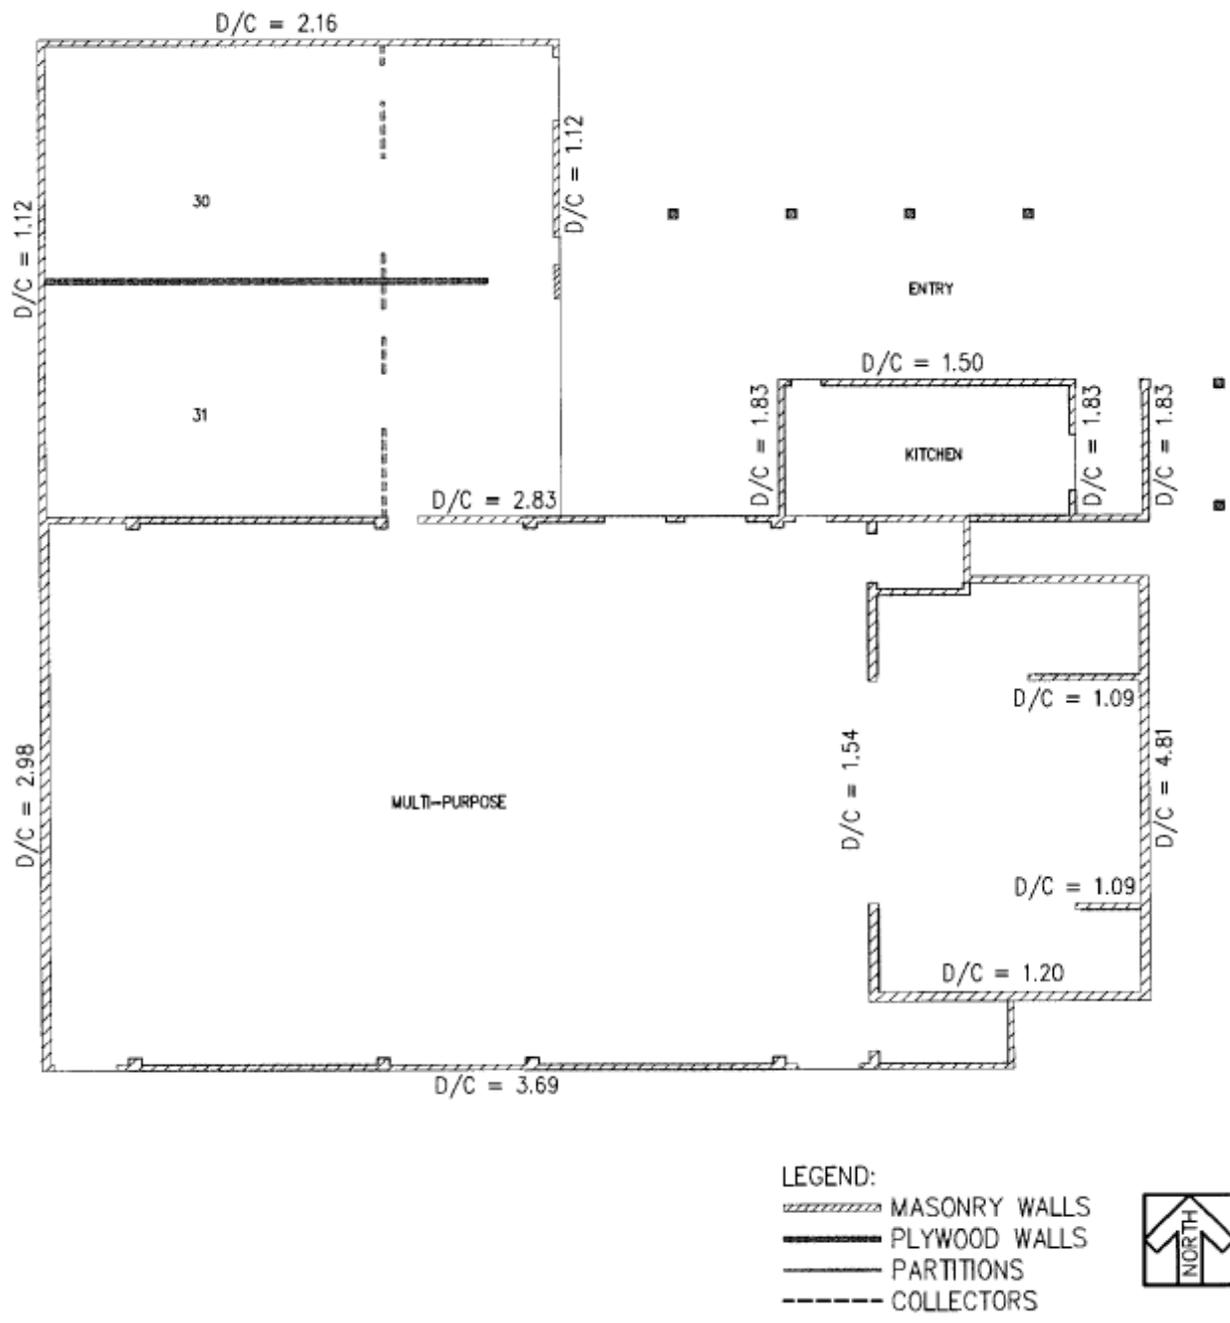
The principal structural deficiency of this building is the weak out-of-plane anchorage between the wood roof and the masonry walls. All masonry walls are not in compliance with out-of-plane anchorage requirements. The D/C ratios for various walls can be seen in Figure 18. These range from 1.12 to 4.81 with five walls having D/C's greater than 2.0. The large D/C ratios are due to the weak sheet metal brackets (H2 clips) shown in Figure 19. This detail is used at many walls throughout the building.

Figure 18 – Building B demand-to-capacity ratios (D/C) for anchorage of the walls to the roof for out-of-plane seismic forces.

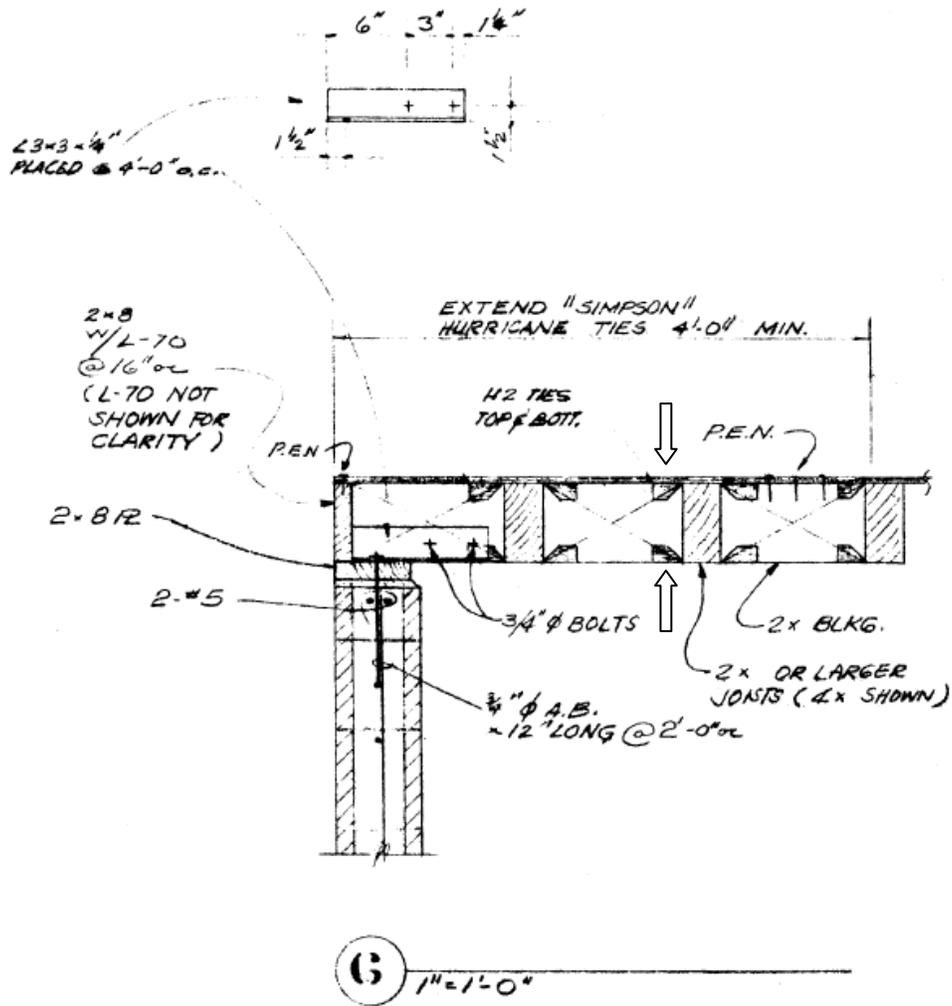
Figure 19 – The wall-roof anchorage connection shown above is used in many places in Building B. In this connection, the weak links are the H2 metal brackets (see arrows). These are greatly overstressed.

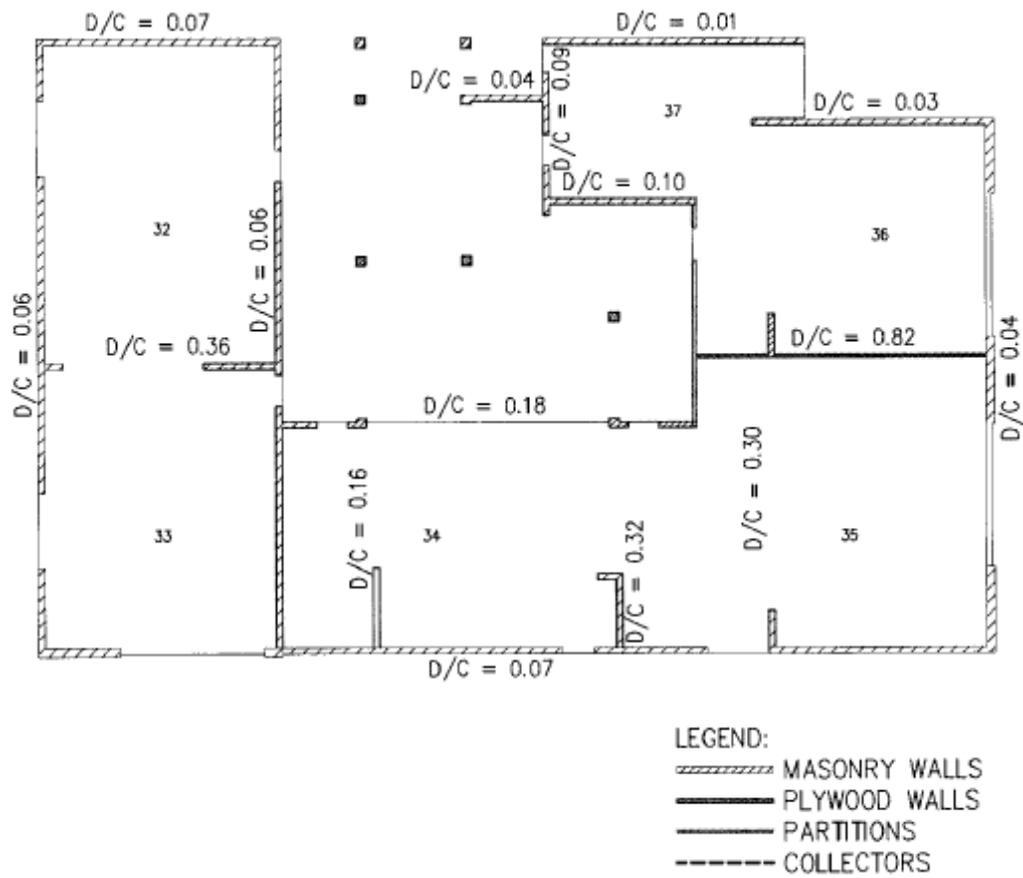
The plywood roof diaphragms and clerestories meet the ASCE 31 criteria. Shear walls also meet criteria. Figure 20 summarizes D/C ratios for the various masonry and plywood shear walls.

Figure 20 – Building C demand-to-capacity ratios (D/C) for shear wall strength.

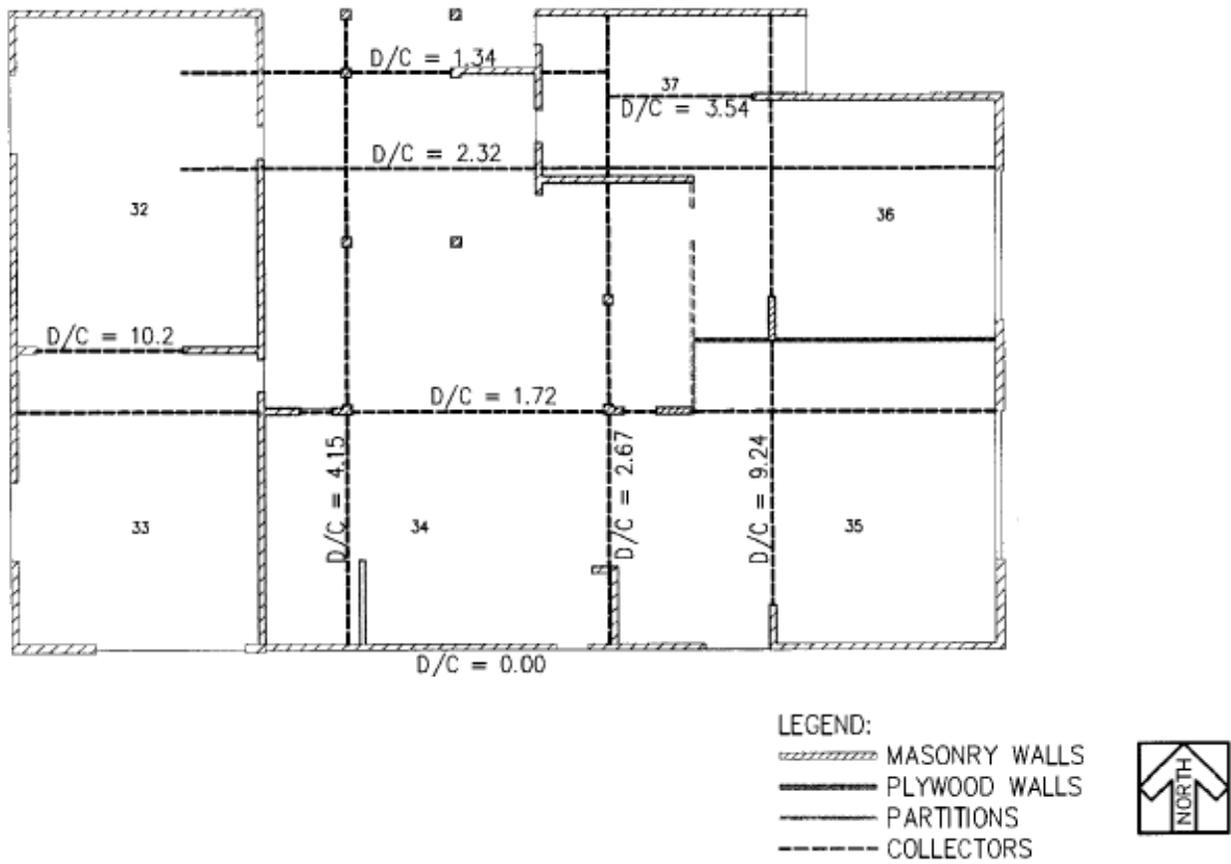
Figure 21 – Building C demand-to-capacity ratios (D/C) for the connection of the roof to the shear walls.

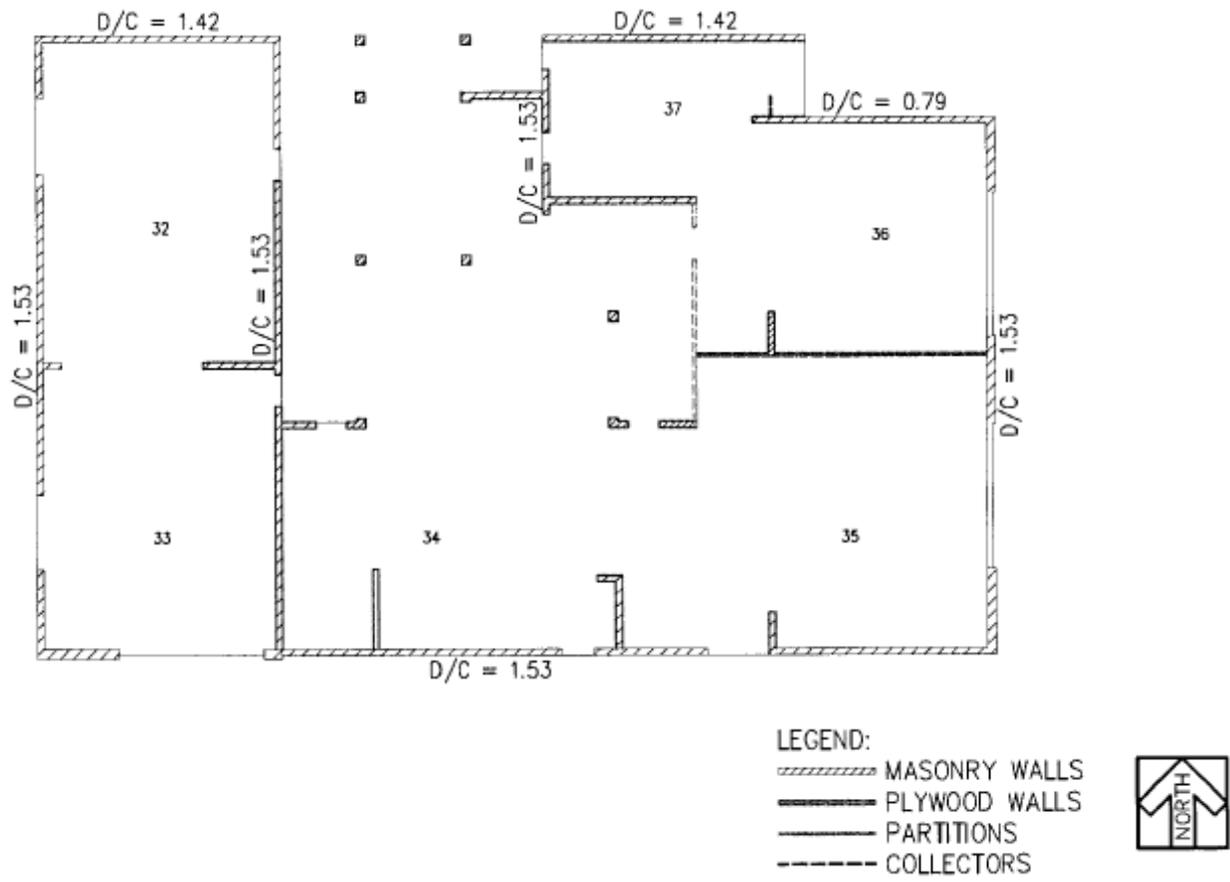
Figure 22 – Building C demand-to-capacity ratios (D/C) for anchorage of the walls to the roof for out-of-plane seismic forces.
