# **Seismic Evaluation of Marin Elementary School**

**Prepared for  
Albany Unified School District  
Albany, CA**

**November 2012**

**Prepared by  
R. P. Gallagher Associates, Inc.  
Structural Engineers  
Oakland, CA**

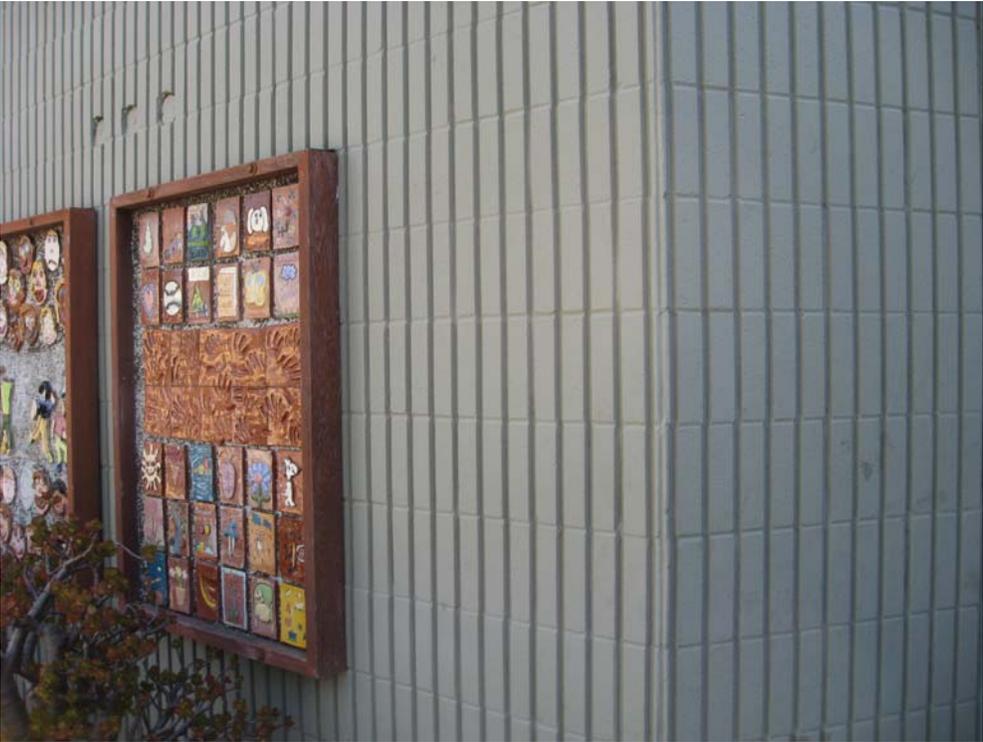
All exterior walls are constructed of reinforced concrete block (also called CMU or concrete masonry units). The block units are “fluted” on both sides (see Figure 6). The drawings do not contain information on the strength of the CMU block or that of the grout used in the construction and there was also no indication that all cells of the block were filled solid with grout. For the evaluation, we assumed a compressive strength of 1,500 psi and that all cells were filled with grout. The latter seems highly likely but should be verified.

The masonry walls are constructed of nominal 6" thick concrete masonry units (CMU). However, the units are "fluted" on both sides and the net thickness is only 4 5/8" (instead of the usual 5 5/8"). The walls are supported by continuous shallow reinforced concrete strip footings. Interior pipe columns are supported on individual concrete spread footings. The perimeter footings are laterally restrained by the concrete slab-on-grade at the building's interior.

Figure 6 – Walls are constructed of “fluted” concrete block. Flutes occur on both interior and exterior faces and reduce the effective thickness of the walls.

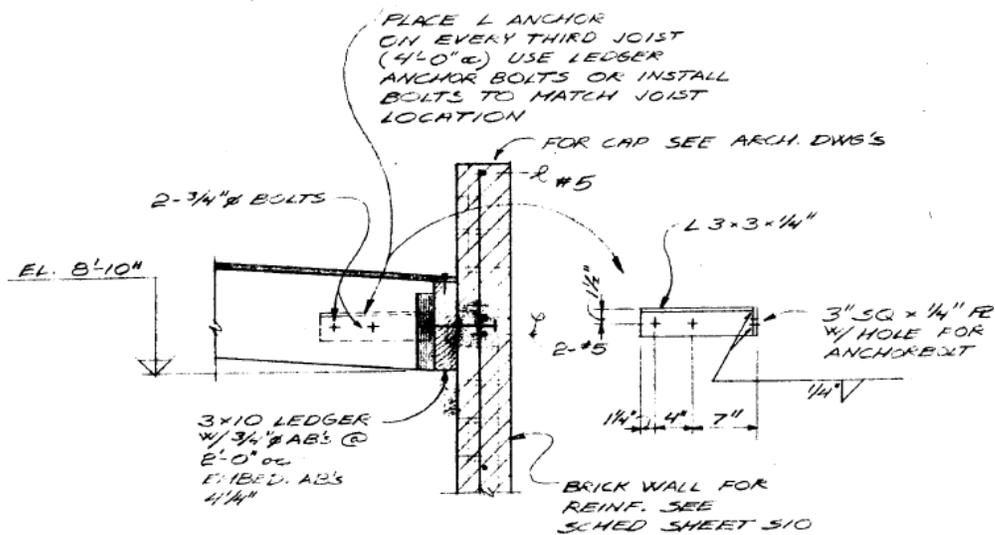
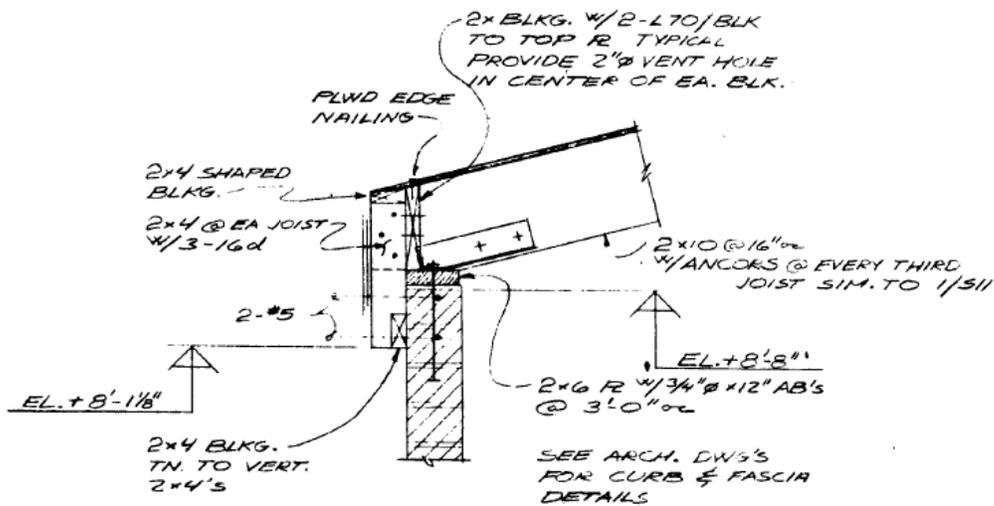
Anchorage of the roof to the CMU walls was checked and found to be deficient. Detail 10 on Figure 7 shows the detail used to connect the 6" CMU walls to the roof in Building D. The ¾ " bolt has only about 2" cover, and the capacity of the bolt in shear perpendicular to the wall is only 12-percent of normal allowable due to the shallow cover. The D/C ratio for this detail is a very high 4.0.

The principal structural deficiency found in the evaluation of Building D (and the other, similar classroom buildings) is the weak anchorage of the exterior walls to the roof. This is a serious deficiency. The  $\frac{3}{4}$ " and 1" anchor bolts connecting the walls and roof have very shallow cover. Although the original design attempted to compensate for this by adding two horizontal bars close to the anchor bolts, the cover is too shallow for the bolts to be very effective.

Anchorage of the roof to the CMU walls was checked and found to be deficient. The D/C ratios ranged from 0.84 to 1.87. The connection shown in Detail 6 of Figure 7 has a D/C of 0.84. The connection shown in Detail 1 of Figure 12 has a D/C of 1.87. The connection of the two large 8 3/4" x 36" glulam beams to the 12" CMU walls is deficient for seismic anchorage forces. The D/C ratio is a high 3.86.

Figure 7 – Examples of wall to roof connections for the Marin buildings. Walls are 6" thick and the allowable capacity of the anchor bolts in Detail 10 is greatly reduced by the shallow cover (i.e., distance between bolt and outside face of block).

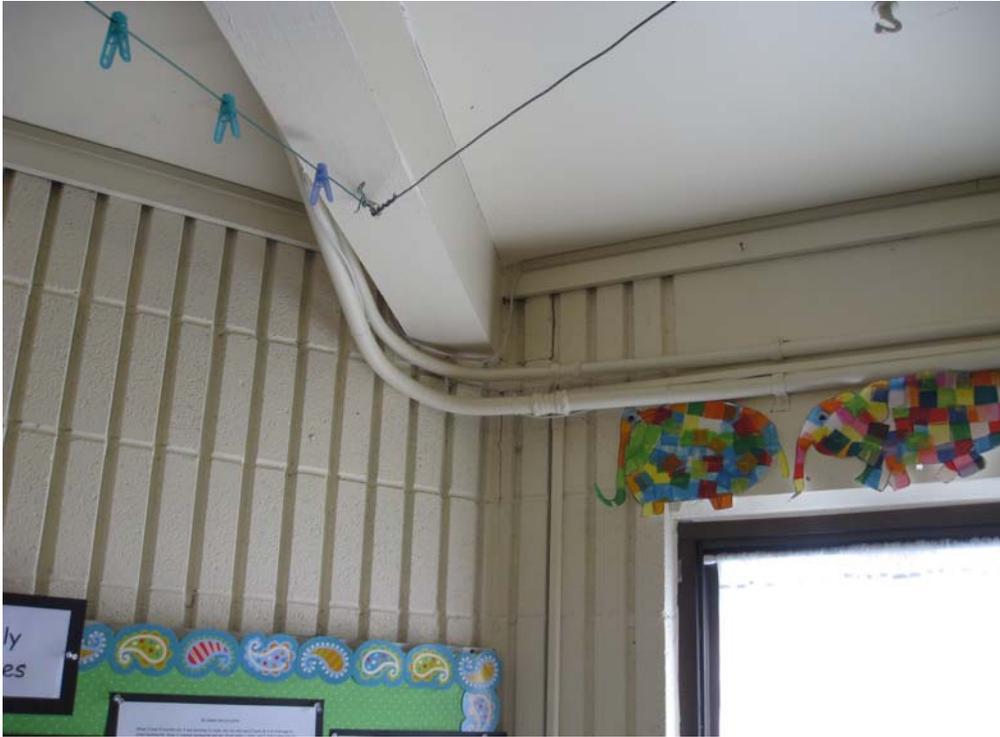
Another very significant deficiency is the anchorage of the 6x18 wood hip beams to the 6" CMU walls (Figures 8 and 9). This connection is very deficient because the three 1" diameter anchor bolts embedded into the wall have only about 1 ¾" cover. Their allowable capacity is only about 7-percent. In other words, they are likely to be ineffective in resisting seismic forces tending to pull the walls away from the roof. Fortunately, the intersecting walls shown in Figures 10 and 11 will help stabilize the walls, but the CMU block in the vicinity of many of the hip

Figure 8 – The large 6x18 wood hip beams in the classroom buildings are supported by bearing on the 6" CMU walls. At this corner, the CMU wall has a very noticeable vertical crack close to the beam.

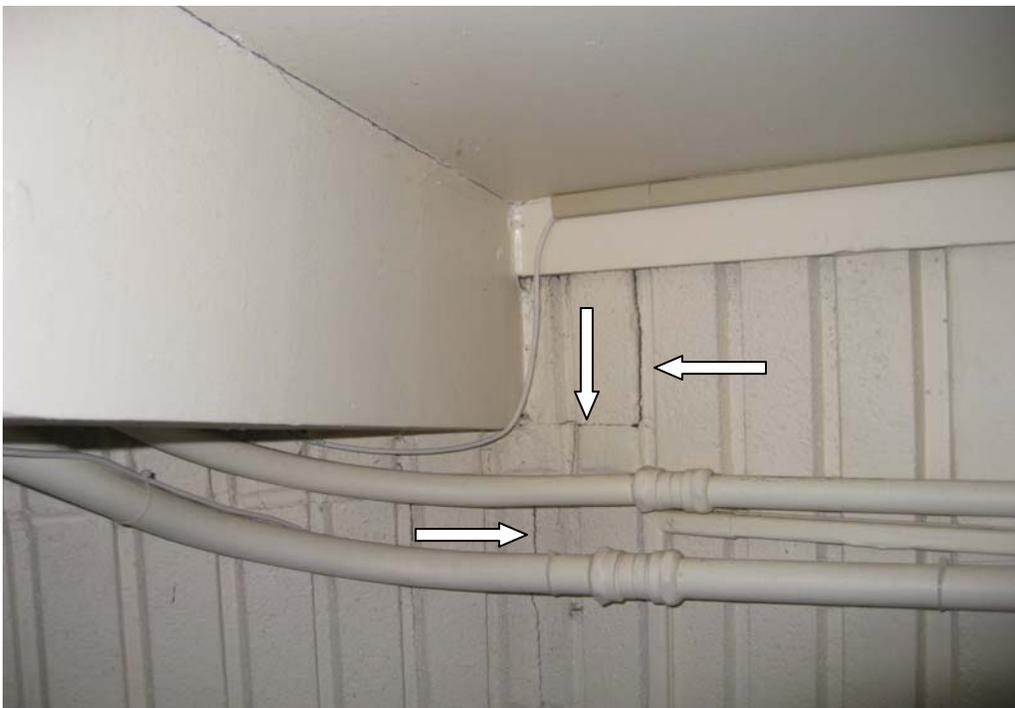
beams is cracked (see Figure 9), making the effectiveness of the beam restraint at the top of the wall doubtful.

Figure 9 – Close up of cracks at 6x18 beam support shown in Figure 8.

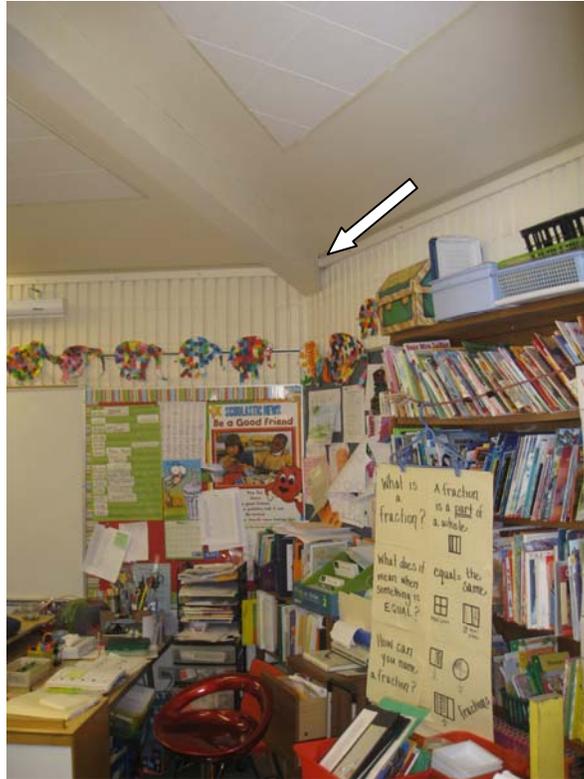
Figure 10 – Example of typical 6x18 hip beam bearing on 6" CMU wall in a classroom building.

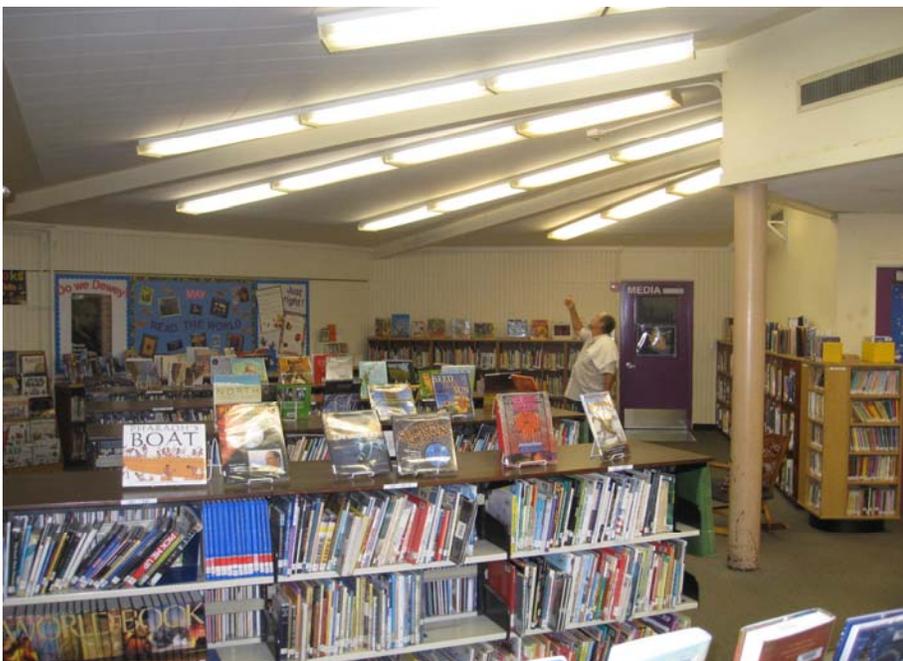
Figure 11 – Interior view of a typical classroom.

In all buildings, extensive nonstructural damage will likely occur. Some of the existing classrooms (Figure 11) are very vulnerable. Bookcases and file cabinets may tip over. Contents will topple from shelves and tabletops. Some windows may break, and doors may jam.

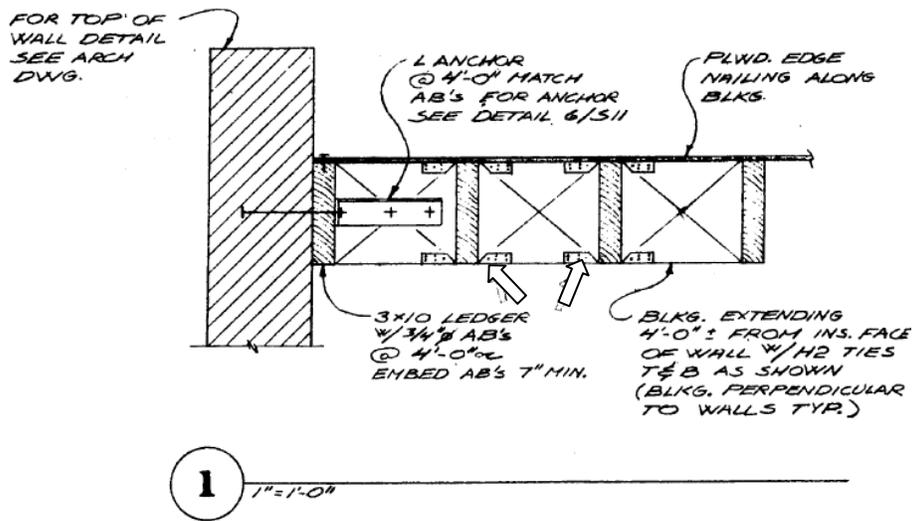
Figure 12 – One of the wall-roof connections used in Building C. In this particular connection, overstressed metal brackets (see arrows) are the weak links in the anchorage system.
