Seismic Evaluation of Ocean View Elementary School

**Prepared for
Albany Unified School District
Albany, CA**

November 2012

**Prepared by
R. P. Gallagher Associates, Inc.
Structural Engineers
Oakland, CA**

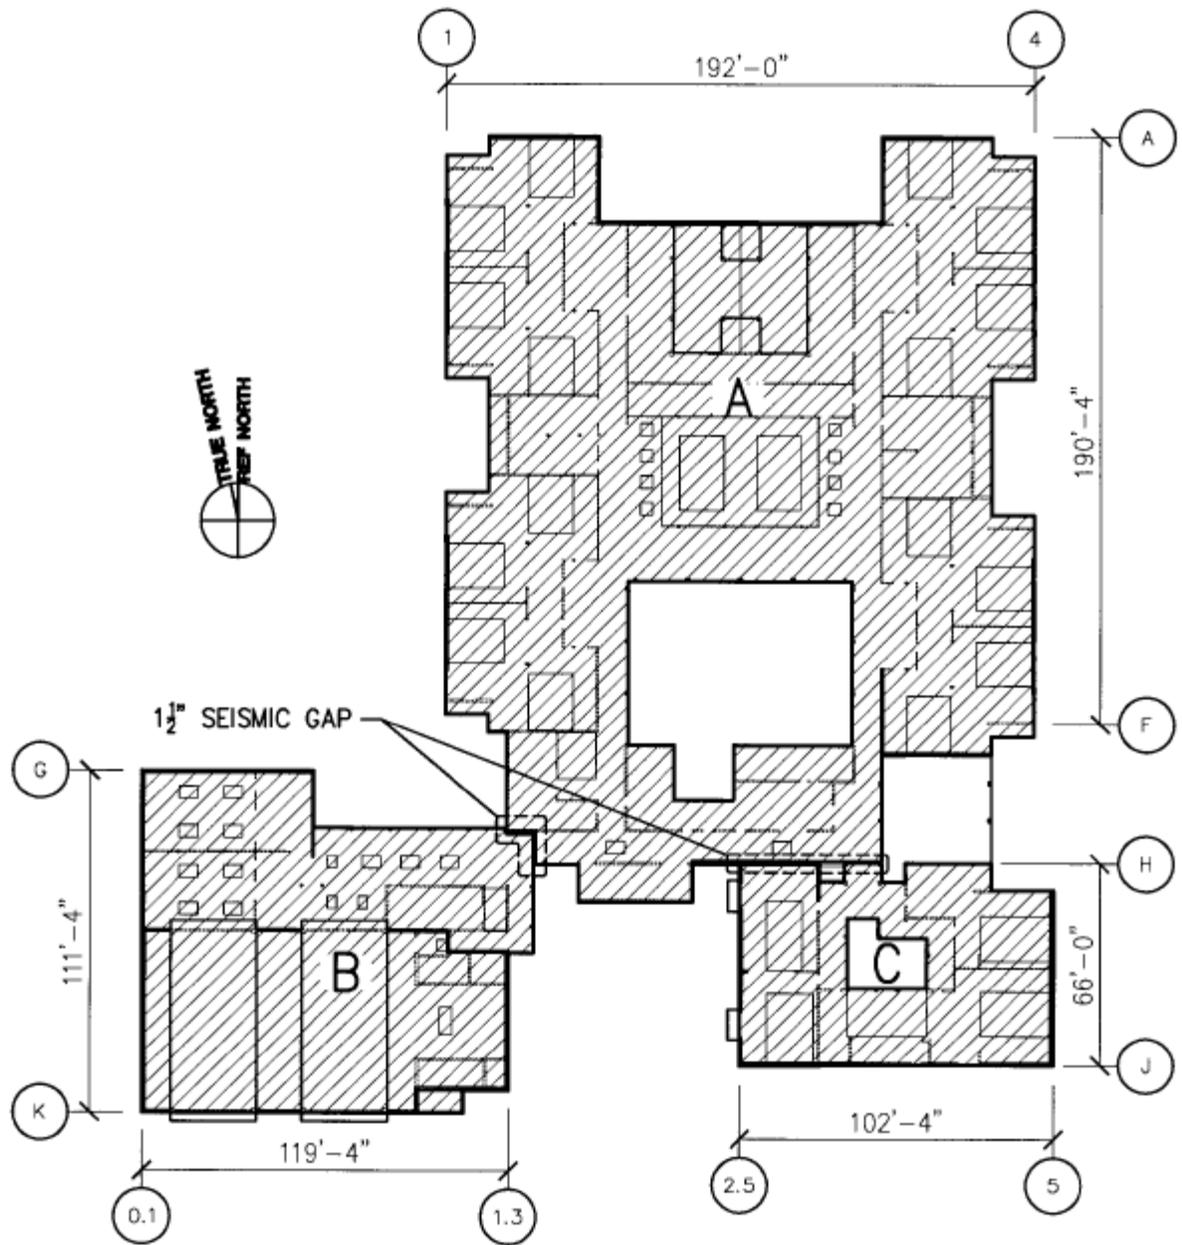
Figure 1 – Site plan showing Buildings A, B and C.

The configuration of the buildings in plan is very irregular. Forces on shear walls were determined by assuming flexible roof diaphragms and that forces are proportional to tributary roof area. There are a great many openings and clerestories in the roofs of Buildings A and C. There are also seismic separation joints between Buildings A and B and between Buildings A and C (see Figure 1).

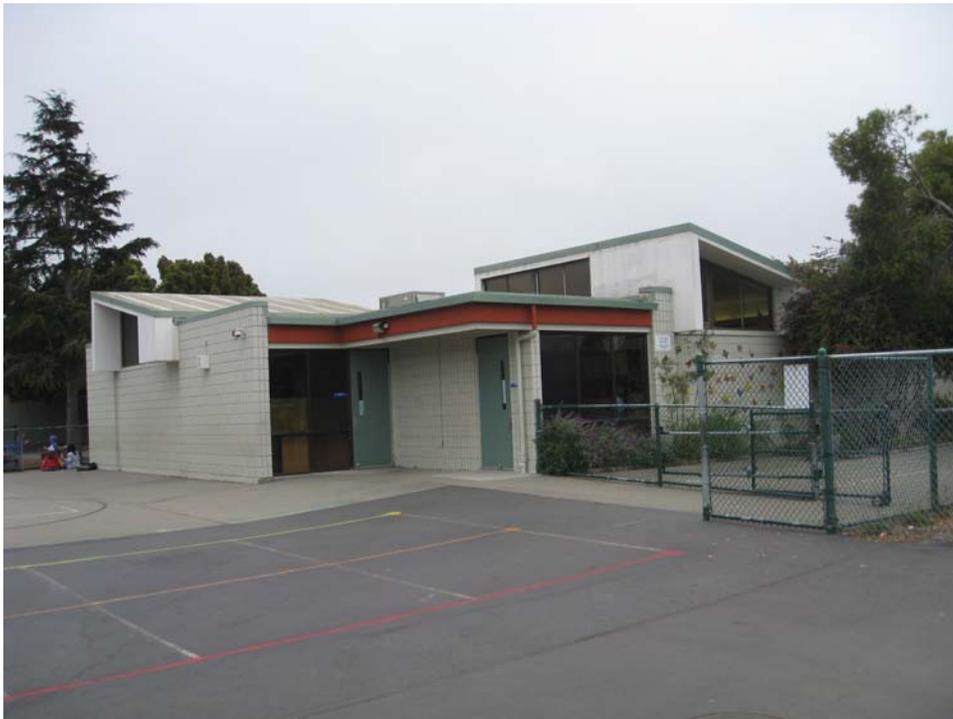
Figure 6 – Northwest corner of Building A. Note clerestory windows above classrooms.

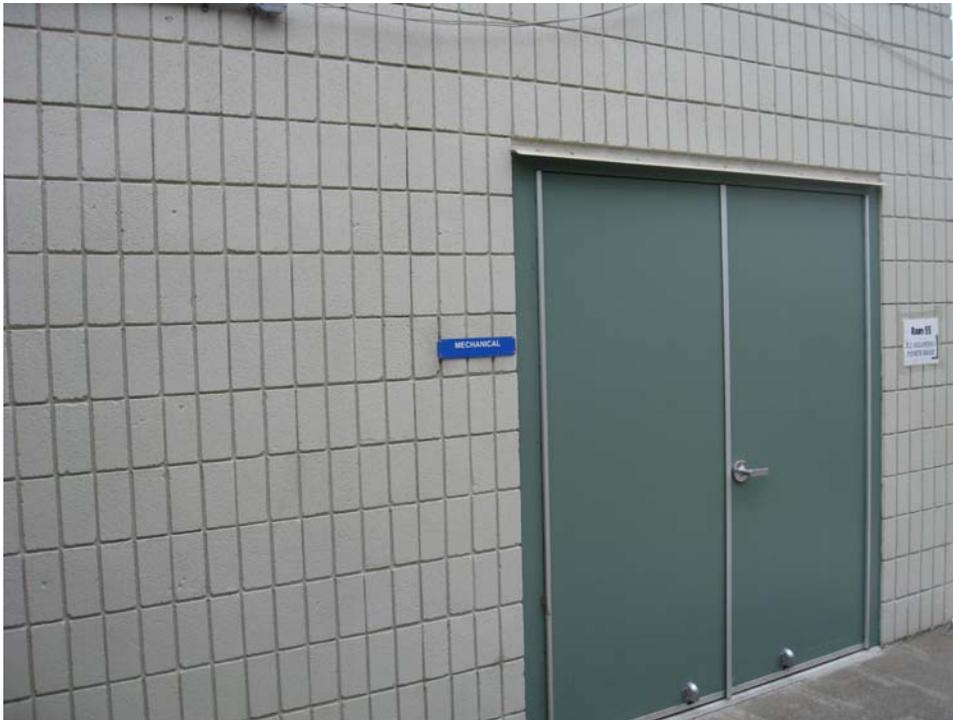
All exterior walls are constructed of reinforced concrete block (also called CMU or concrete masonry units). The block units are “fluted” on one side (see Figure 10) and the net thickness is reduced 3/8 inch. A nominal 8” block has a net thickness of 7¼ (instead of the usual 7 5/8”). The drawings do not contain information on the strength of the CMU block or that of the grout used in the construction. All cells of the block are indicated on the drawings to be filled solid with grout. For the evaluations, we assumed a compressive strength of 1,500 psi for the block.

Figure 10 – Concrete block is fluted on one side for all buildings. Flutes are 3/8 inch deep.
