# **Seismic Evaluation of Marin Elementary School**

**Prepared for  
Albany Unified School District  
Albany, CA**

**November 2012**

**Prepared by  
R. P. Gallagher Associates, Inc.  
Structural Engineers  
Oakland, CA**

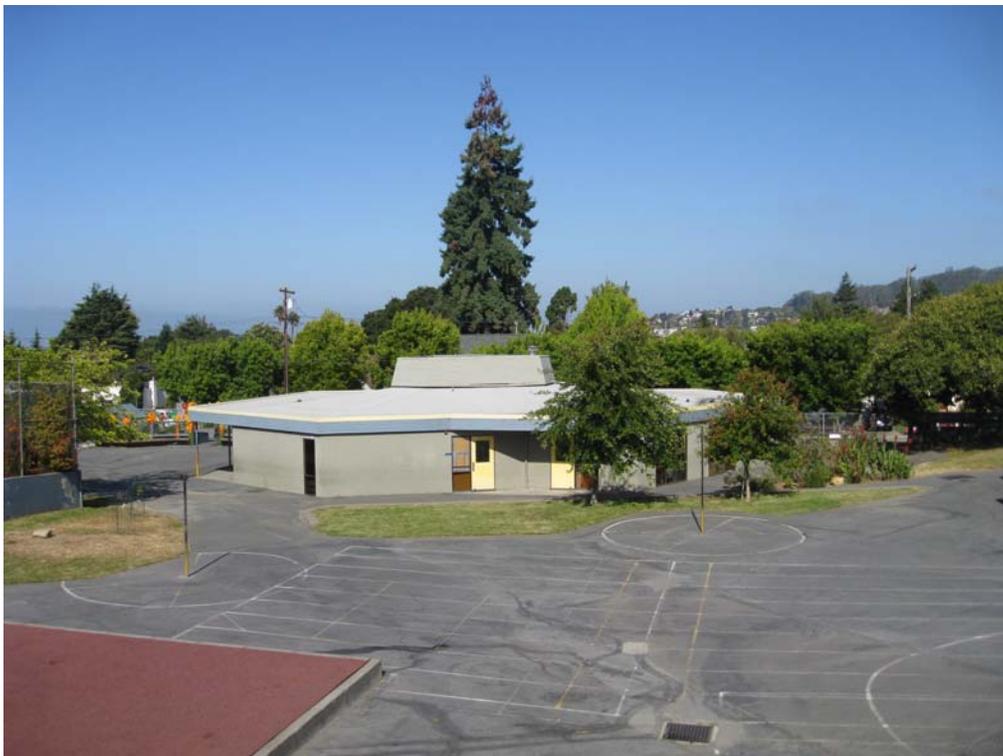
Figure 4 – Classroom Building A.

Building A (Figure 4) is a single story, nine-side structure of approximately 3,450 square feet. Overall dimensions are approximately 68' by 72' in plan. Other than the different footprint, the construction of Building A is similar to Building D and the other classrooms. All exterior masonry walls are 6" CMU.

The results for Building A are essentially the same as those for Building D. The significant deficiencies are the same (weak anchorage of the walls to the roof that can lead to wall-roof separation).

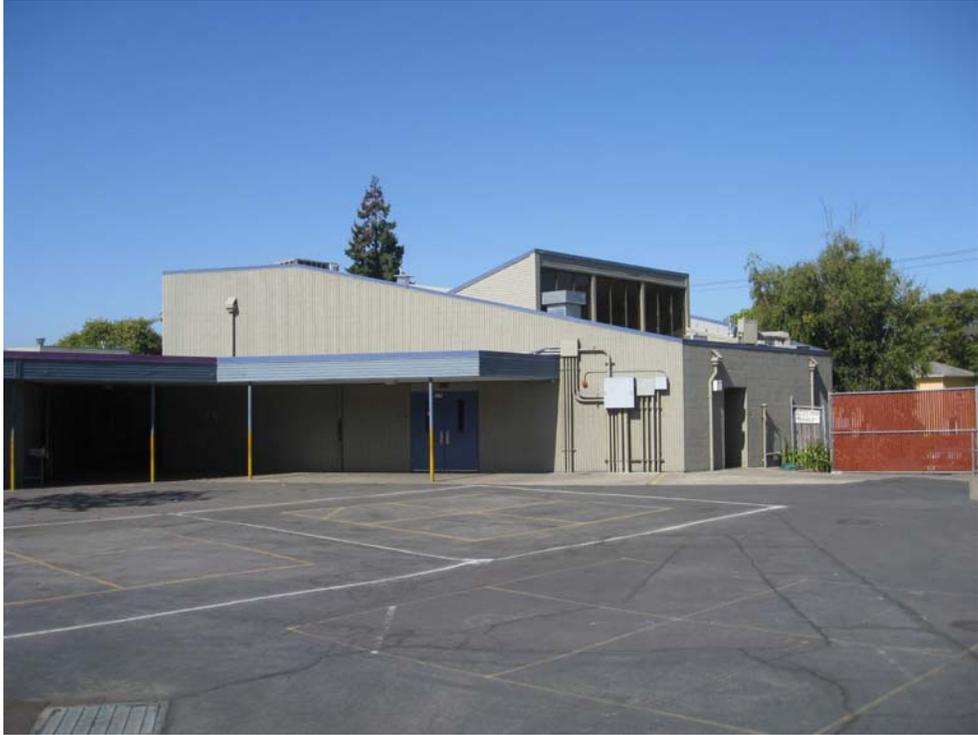
Figure 5 – Multi-purpose Building C.

Building C (Figure 5) is a seven-sided single story structure. The building has a floor area of approximately 4,220 square feet. Overall dimensions are approximately 86' by 64' in plan.

Building C does not meet the ASCE 31 criteria. The anchorage of the tops of masonry walls to the roof diaphragm is inadequate. This and other findings are discussed below.

Anchorage of the roof to the CMU walls was checked and found to be deficient. The D/C ratios ranged from 0.84 to 1.87. The connection shown in Detail 6 of Figure 7 has a D/C of 0.84. The connection shown in Detail 1 of Figure 12 has a D/C of 1.87. The connection of the two large 8 3/4" x 36" glulam beams to the 12" CMU walls is deficient for seismic anchorage forces. The D/C ratio is a high 3.86.

With the exception of the plywood shear wall anchorage, the roof diaphragm and the shear walls (CMU and plywood) of Building C easily meet ASCE 31 criteria. The main deficiencies found are the inadequate wall connections to the roof and glulam beams, the diaphragm chords, and the anchorage of the interior wood shear walls.
